Manhole Inspection Summary

Manhole # S39Y1_018MH

Insp Date: **11/15/07 2:50 PM**

Location Address: **403 Cambria Street**

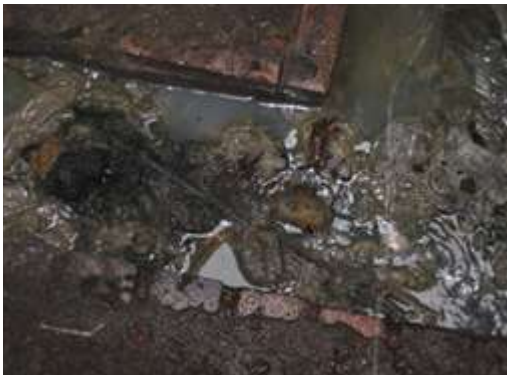
Location View

debris

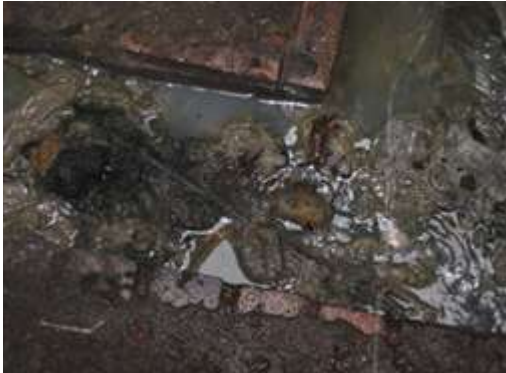
Defect 5

debris

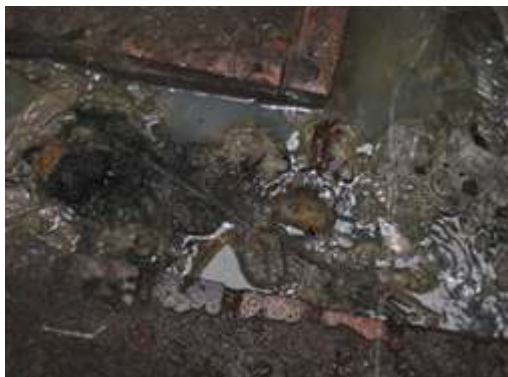
Defect 6

debris

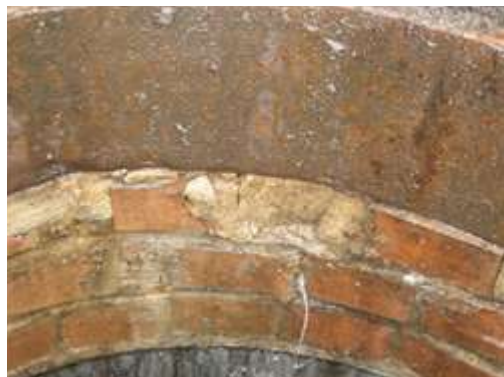
Defect 1

Condition: ☐ Sound ☐ Cracked ☐ Root Intrusion ☒ **Loose Brick** ☐ Deteriorated

loose bricks

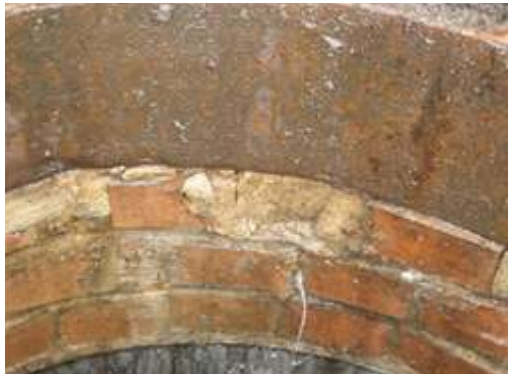
Defect 3

loose bricks at chimney

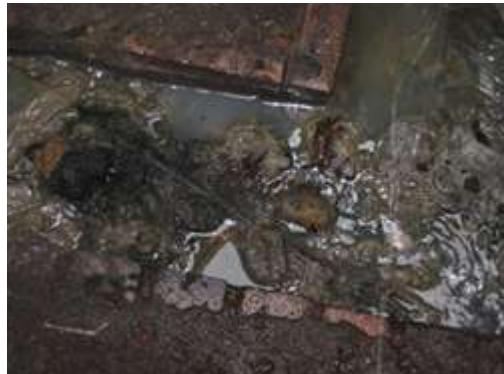
Defect 2

debris

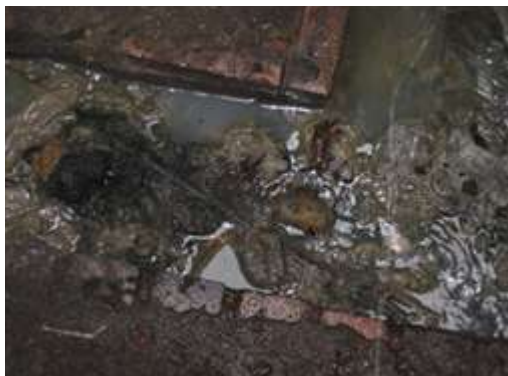
Defect 4

debris

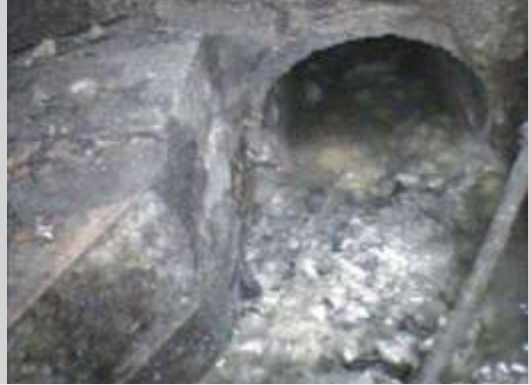
12 O'Clock Outflow

Pipe Height: **9.6** (in.) Rod and Bar (Angled)
Pipe Material: **Clay** ☐ Pipe Lined
Invert Depth: **7.28** (ft.) Flow Characteristics: **Slow**
Deposits: ☒ None ☐ Mud ☐ Sludge ☐ Debris ☐ Grease
Silt Depth: (in.) Deposits Extent:
Infiltration: **None** Pipe Seal Cond: **Sound**

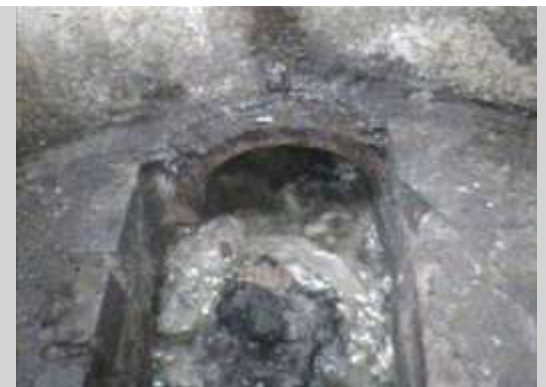
6 O'Clock Inflow

Pipe Height: **9.6** (in.) Rod and Bar (Angled)
Pipe Material: **Clay** ☐ Pipe Lined
Invert Depth: **7.06** (ft.) Flow Characteristics: **Slow**
Deposits: ☒ None ☐ Mud ☐ Sludge ☐ Debris ☐ Grease
Silt Depth: (in.) Deposits Extent:
Infiltration: **None** Pipe Seal Cond: **Sound**

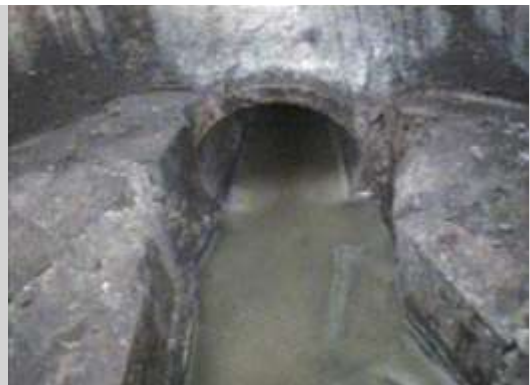
9 O'Clock Inflow

Pipe Height: **8.4** (in.) Rod and Bar (Angled)

Infiltration: **None** Pipe Seal Cond: **Sound**
